Appendix F2 – Assessment of Controls (Stormwater Management Assessment)

Wexford 2016 Annual Physical Assessment

Harford County Department
of Public Works

December 2016

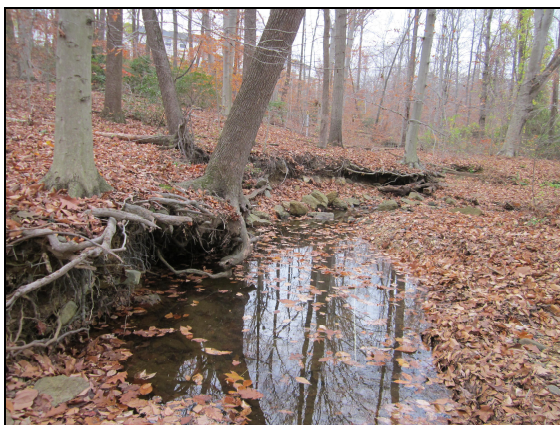
2015 Survey: STA 8+25, looking upstream

The profile and cross section data collected for 2016 were superimposed over the data collected for years 2012 to 2015. The 2016 profile data generally shows a slight trend of channel thalweg incision and pool deepening, especially in the lower 1,200 linear feet. The channel appears unable to transport the sediment load, which results in large mid-channel and lateral bar formation. These depositional features, comprised of cobble size material, increase near bank shear stresses that result in erosion of the bank and bed. Downed trees and large wood debris have also caused local bed and bank erosion at several locations. Several large trees were observed to have fallen in the stream channel between the 2015 and 2016 surveys. Specific examples can be seen in the photographs below.

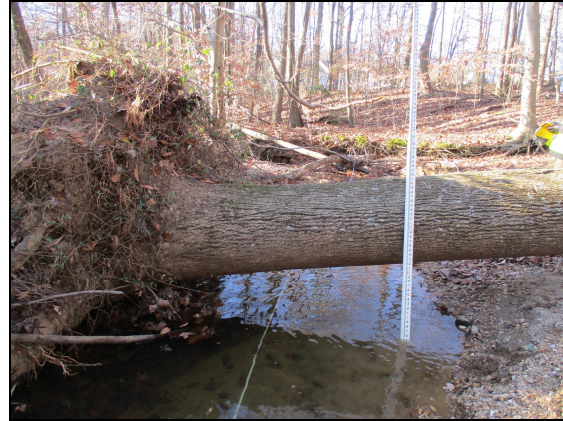
2016 Survey: STA 19+50, looking downstream

Notable changes in the channel bed include from station 18+00 to 24+00, where the channel appears to be downcutting and pools have deepened. Scour pools due to log jams are present at station 12+90 and 14+40. Throughout the reach, large lateral and mid-channel bars, comprised of loose sand and gravel overwhelm the channel and are frequently shifted by storm flows. This is most obvious in the lower half of the reach, as the thalweg has shifted as a result of mobilization of the sand and gravel bars. The stream banks and bed in the vicinity of the sewer encasement at station 23+90 continue to degrade, the area should be monitored closely.

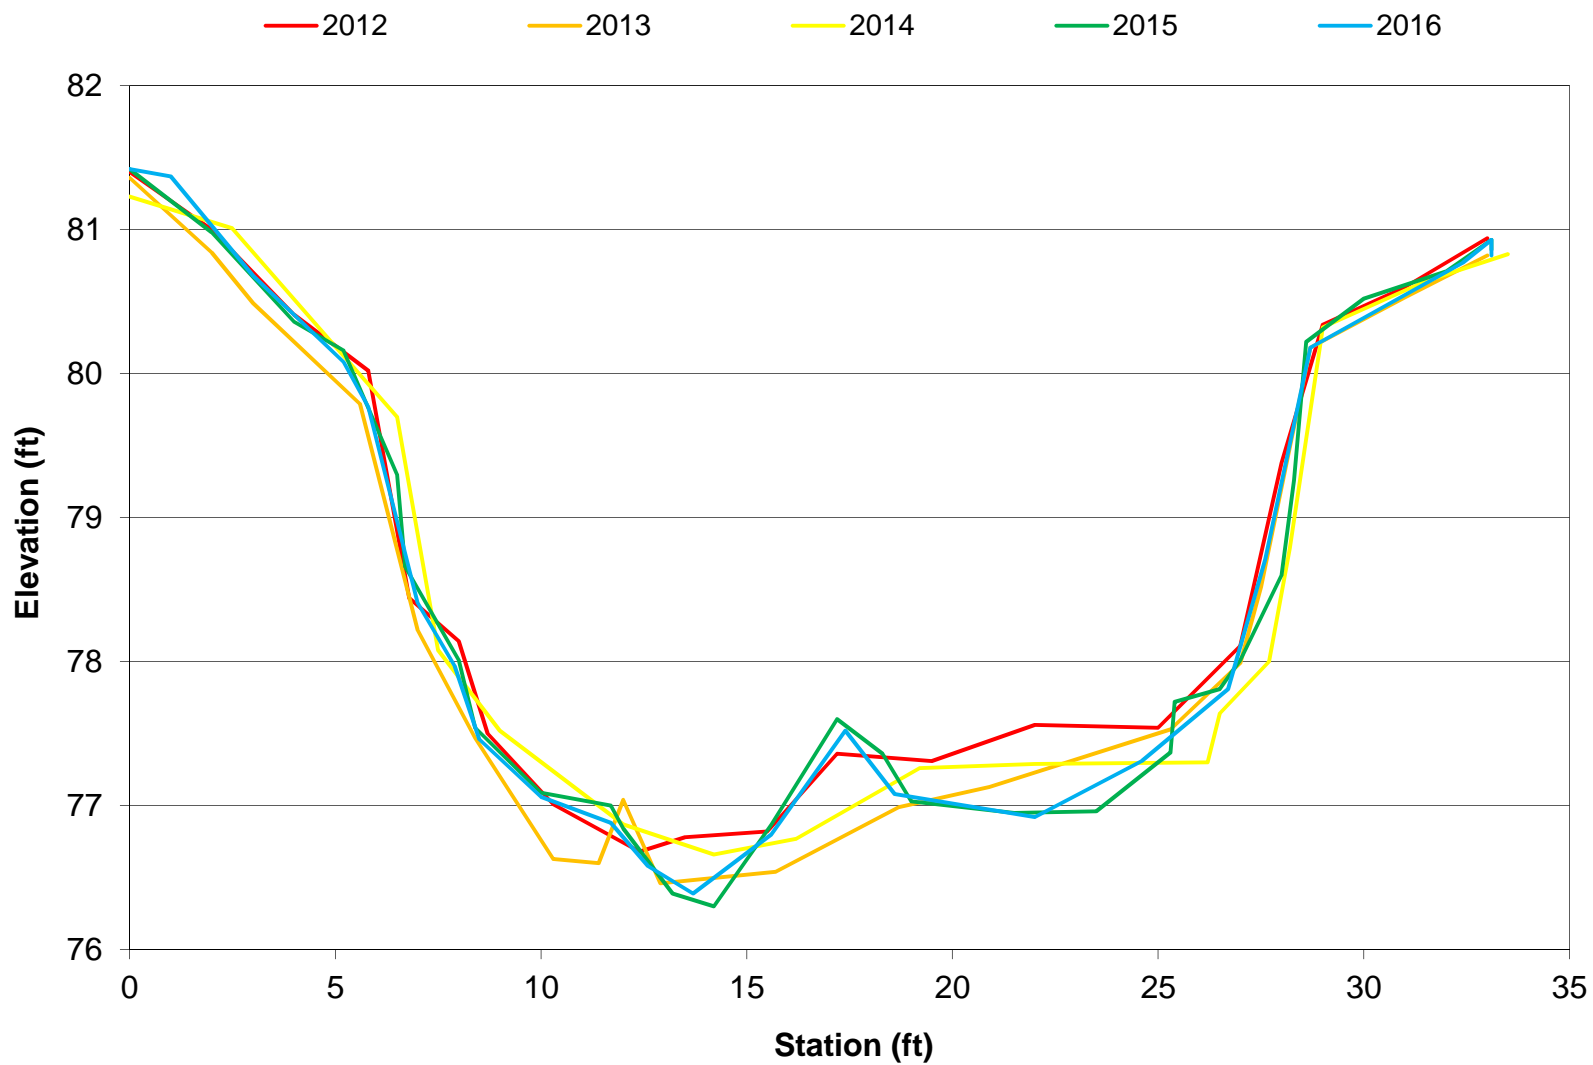
**Cross Section 1
Station 3+00**

All four of the cross sections classify as unstable F4 type channels with entrenchment ratios of 1.2 - 1.4 and width to depth ratios greater than 12. Sediment supply is high due to eroding stream banks and results in frequent transverse bars and riffles. The 2016 survey shows little change to cross section 1. Cross section 2 continues its slow left bank retreat due to high near bank stress caused by deposition along the right side of the channel. Cross section 3 shows some minor bed incision. Cross section 4 shows the most change this year with some minor bed incision and erosion along the lower section of the right bank.
